**Flood Control Project Maintenance
Levee Inspections**

Fall 2019 Levee Maintenance Deficiency Summary Report

**Flood Control Project Maintenance
Levee Inspections****LMA District Cover Sheet****Fall 2019 Levee Inspection Results****Sacramento River West Side Levee District**

Sacramento River West Side Levee District

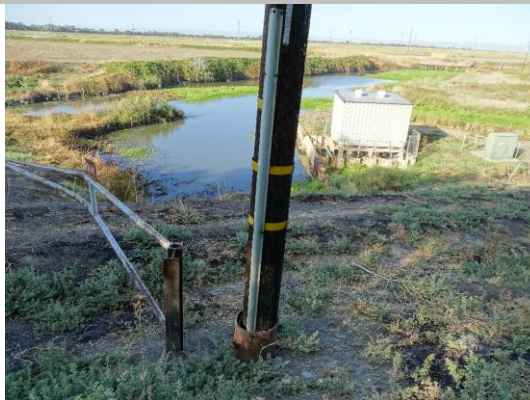
Photo 1 of 3 : UCIP_FA_2019_55790_82901.jpg

LM Start	0.14	Rating **	M	Issue No.	1551	
LM End	0.14	Issue Type +	En	Location *		
Category	Supplemental			GPS Latitude/Longitude		
				Start	End	
Item	DRAFT DWR UCIP Field Study			38.801427 °	38.801427 °	
				-121.725158 °	-121.725158 °	
DWR ID	20223					
Comment Code						
Inspector Comment						
DS_ID:20223 FS_ID:55790 EP_NO: 12149 Repair Type: Non-Urgent Crossing Status: Found UCIP Comments: 09/30/2019 Telephone cable is disconnected on the pole. If telephone line is abandoned has to be done properly. (O.Yakimov - DWR UCIP) FIELD_STRUCT_DESC: 1.5-inch galvanized steel telephone conduit through the levee, 5.0 feet below the crown. (Permit No. 12149, 1977 - Continental Telephone Company of California). Line originates at pole on landside (LS) shoulder. [Additional Reference(s): DWR Levee Log, 2006]. FS Date: 9/30/2019

Conduit enters levee LS slope at the pole

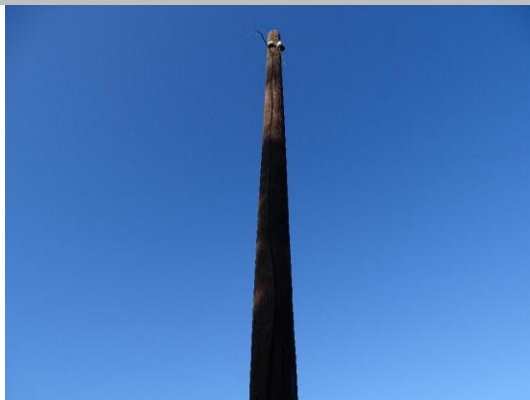
Photo 2 of 3 : UCIP_FA_2019_55790_82902.jpg

Disconnected cable on top of the pole

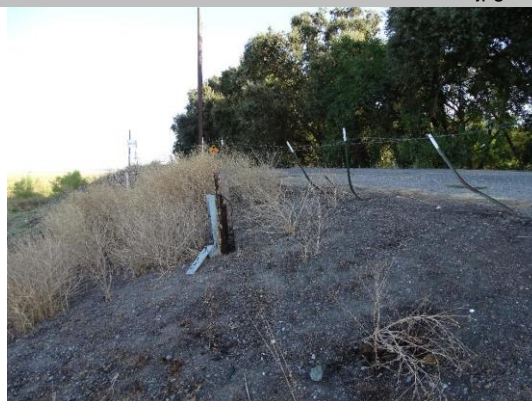
Photo 3 of 3 : UCIP_FA_2019_55790_82903.jpg

LM Start	0.14	Rating **	M	Issue No.	1551 (cont)	
LM End	0.14	Issue Type +	En	Location *		
Category	Supplemental			GPS Latitude/Longitude		
				Start		End
Item	DRAFT DWR UCIP Field Study			38.801427 °		38.801427 °
				-121.725158 °		-121.725158 °
DWR ID	20223					
Comment Code						
Inspector Comment						
DS_ID:20223 FS_ID:55790 EP_NO: 12149 Repair Type: Non-Urgent Crossing Status: Found UCIP Comments: 09/30/2019 Telephone cable is disconnected on the pole. If telephone line is abandoned has to be done properly. (O.Yakimov - DWR UCIP) FIELD_STRUCT_DESC: 1.5-inch galvanized steel telephone conduit through the levee, 5.0 feet below the crown. (Permit No. 12149, 1977 - Continental Telephone Company of California). Line originates at pole on landside (LS) shoulder. [Additional Reference(s): DWR Levee Log, 2006]. FS Date: 9/30/2019

Abandoned telephone connection box on LS slope

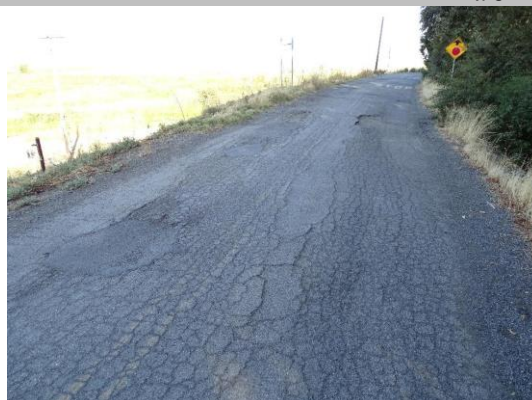
Photo 1 of 3 : UCIP_FA_2019_55791_82904.jpg

Comment Code						
Inspector Comment						
DS_ID:20224 FS_ID:55791 EP_NO: N/A Repair Type: Urgent Crossing Status: Found UCIP Comments: 09/30/2019 Erosion around headwall on WS progresses. Roger Cornwell who is a head of an irrigation district that operates the plant has been notified. Needs to run pumps to see if erosion is caused by leaking pipe(s). (O.Yakimov - DWR UCIP)03/12/2013 Headwall on WS undermined about 3-4-feet. FIELD_STRUCT_DESC: 1 of 3: 36-inch steel drainage pipe through the levee, 30.0 feet below the crown. Flap gate on the waterside (WS) end. 24-inch pipe sleeved through the 36-inch pipe. Annular space between pipes grouted. Pumps in pump house with walkway on landside (LS) toe. [Additional Reference(s): DWR Levee Log, 2006. USACE Sacramento O&M Manual 130, May 1960 (HLM 0.15)]. FS Date: 9/30/2019 7:39:29 AM

View of levee crown at the crossing

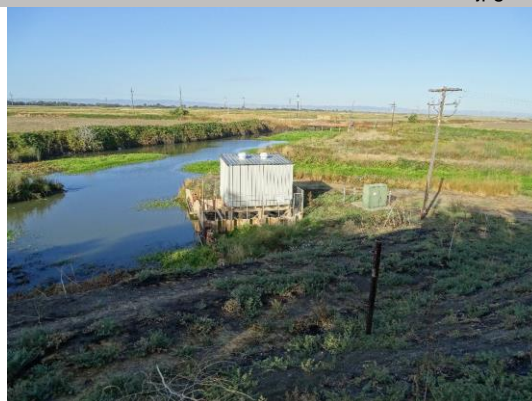
Photo 2 of 3 : UCIP_FA_2019_55791_82909.jpg

Comment Code						
Inspector Comment						
DS_ID:20224 FS_ID:55791 EP_NO: N/A Repair Type: Urgent Crossing Status: Found UCIP Comments: 09/30/2019 Erosion around headwall on WS progresses. Roger Cornwell who is a head of an irrigation district that operates the plant has been notified. Needs to run pumps to see if erosion is caused by leaking pipe(s). (O.Yakimov - DWR UCIP)03/12/2013 Headwall on WS undermined about 3-4-feet. FIELD_STRUCT_DESC: 1 of 3: 36-inch steel drainage pipe through the levee, 30.0 feet below the crown. Flap gate on the waterside (WS) end. 24-inch pipe sleeved through the 36-inch pipe. Annular space between pipes grouted. Pumps in pump house with walkway on landside (LS) toe. [Additional Reference(s): DWR Levee Log, 2006. USACE Sacramento O&M Manual 130, May 1960 (HLM 0.15)]. FS Date: 9/30/2019 7:39:29 AM

View of LS looking from levee crown

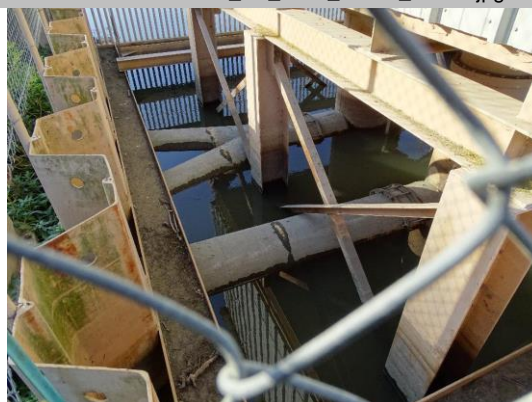
Photo 3 of 3 : UCIP_FA_2019_55791_82908.jpg

Pipe underneath pump house

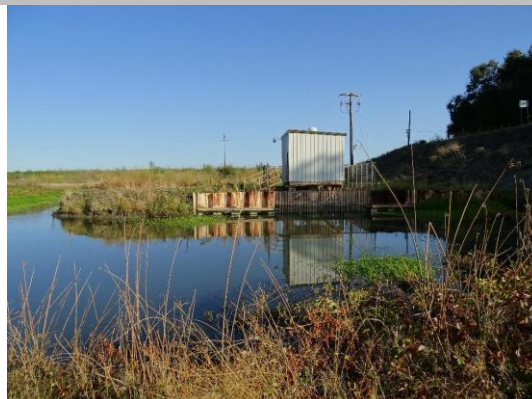
Photo 2 of 3 : UCIP_FA_2019_55792_82911.jpg

Comment Code						
Inspector Comment						
DS_ID:20356 FS_ID:55792 EP_NO: N/A Repair Type: Urgent Crossing Status: Found UCIP Comments: 09/30/2019 Erosion around headwall on WS progresses. Roger Cornwell who is a head of an irrigation district that operates the plant has been notified. Needs to run pumps to see if erosion is caused by leaking pipe(s). (O.Yakimov - DWR UCIP)03/12/2013 Headwall undermined 3-4-feet on WS toe. FIELD_STRUCT_DESC: 2 of 3: 36-inch steel drainage pipe through the levee, 30 feet below the crown. Flap gate on the waterside (WS) end. 24-inch pipe sleeved through the 36-inch pipe. Annular space between pipes grouted. Pumps inside pump house with a walkway on the landside (LS) toe. [Additional Reference(s): DWR Levee Log, 2006. USACE Sacramento O&M Manual 130, May 1960 (HLM 0.15)]. FS Date: 9/30/2019 8:01:37 AM

Pumping plant on LS

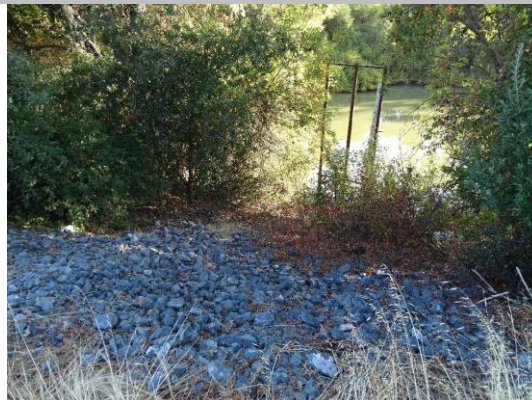
Photo 3 of 3 : UCIP_FA_2019_55792_82916.jpg

Comment Code						
Inspector Comment						
DS_ID:20356 FS_ID:55792 EP_NO: N/A Repair Type: Urgent Crossing Status: Found UCIP Comments: 09/30/2019 Erosion around headwall on WS progresses. Roger Cornwell who is a head of an irrigation district that operates the plant has been notified. Needs to run pumps to see if erosion is caused by leaking pipe(s). (O.Yakimov - DWR UCIP)03/12/2013 Headwall undermined 3-4-feet on WS toe. FIELD_STRUCT_DESC: 2 of 3: 36-inch steel drainage pipe through the levee, 30 feet below the crown. Flap gate on the waterside (WS) end. 24-inch pipe sleeved through the 36-inch pipe. Annular space between pipes grouted. Pumps inside pump house with a walkway on the landside (LS) toe. [Additional Reference(s): DWR Levee Log, 2006. USACE Sacramento O&M Manual 130, May 1960 (HLM 0.15)]. FS Date: 9/30/2019 8:01:37 AM

WS levee slope and air vents

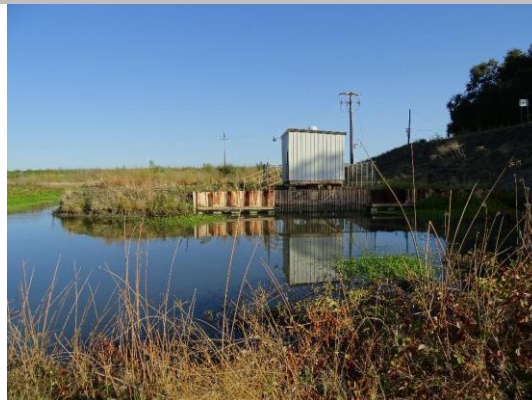
Photo 1 of 3 : UCIP_FA_2019_55793_82917.jpg

Comment Code						
Inspector Comment						
DS_ID:20357 FS_ID:55793 EP_NO: N/A Repair Type: Urgent Crossing Status: Found UCIP Comments: 09/30/2019 Erosion around headwall on WS progresses. Roger Cornwell who is a head of an irrigation district that operates the plant has been notified. Needs to run pumps to see if erosion is caused by leaking pipe(s). (O.Yakimov - DWR UCIP)03/12/2013 Headwall undermined 3-4-feet on WS toe. FIELD_STRUCT_DESC: 3 of 3: 36-inch steel drainage pipe through the levee, 30 feet below the crown. Flap gate on the waterside (WS) end. 24-inch pipe sleeved through the 36-inch pipe. Annular space between pipes grouted. Pumps inside pump house with a walkway on the landside (LS) toe. [Additional Reference(s): DWR Levee Log, 2006. USACE Sacramento O&M Manual 130, May 1960 (HLM 0.15)]. FS Date: 9/30/2019 8:02:02 AM

Pump house on LS

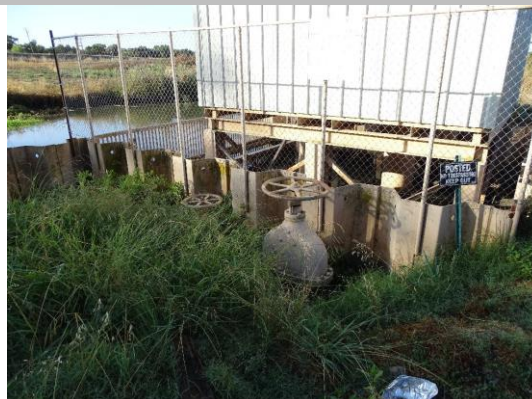
Photo 2 of 3 : UCIP_FA_2019_55793_82920.jpg

Slide gates at pumphouse on LS toe

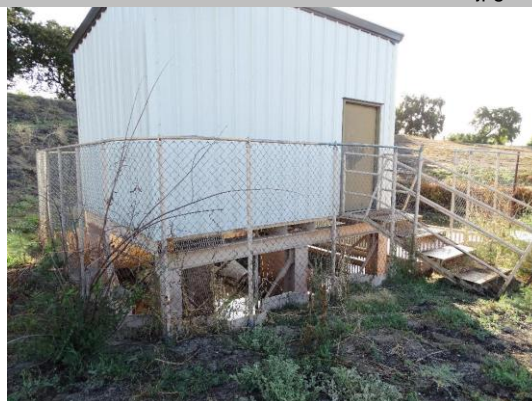
Photo 3 of 3 : UCIP_FA_2019_55793_82921.jpg

Comment Code						
Inspector Comment						
DS_ID:20357 FS_ID:55793 EP_NO: N/A Repair Type: Urgent Crossing Status: Found UCIP Comments: 09/30/2019 Erosion around headwall on WS progresses. Roger Cornwell who is a head of an irrigation district that operates the plant has been notified. Needs to run pumps to see if erosion is caused by leaking pipe(s). (O.Yakimov - DWR UCIP)03/12/2013 Headwall undermined 3-4-feet on WS toe. FIELD_STRUCT_DESC: 3 of 3: 36-inch steel drainage pipe through the levee, 30 feet below the crown. Flap gate on the waterside (WS) end. 24-inch pipe sleeved through the 36-inch pipe. Annular space between pipes grouted. Pumps inside pump house with a walkway on the landside (LS) toe. [Additional Reference(s): DWR Levee Log, 2006. USACE Sacramento O&M Manual 130, May 1960 (HLM 0.15)]. FS Date: 9/30/2019 8:02:02 AM

Pump house view from LS looking towards levee

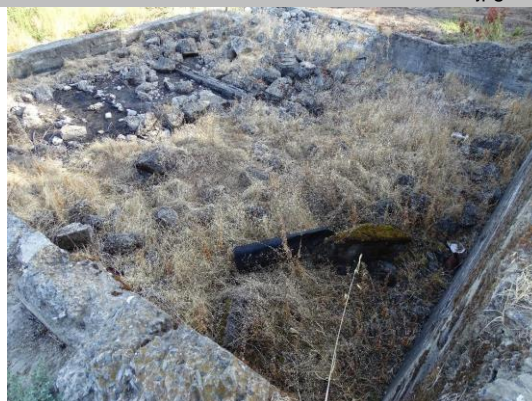
Photo 1 of 2 : UCIP_FA_2019_55794_82922.jpg

LM Start	0.22	Rating **	M	Issue No.	1555
LM End	0.22	Issue Type +	Ma	Location *	
Category	Supplemental			GPS Latitude/Longitude	
				Start	End
Item	DRAFT DWR UCIP LMA Responsibility			38.802293 °	38.802293 °
				-121.724847 °	-121.724847 °
DWR ID	20327				
Comment Code					
Inspector Comment					
DS_ID:20327					
FS_ID:55794					
EP_NO: N/A					
Repair Type: Non-Urgent					
Crossing Status: Found					
UCIP Comments: 09/30/2019 Crossing looks abandoned (O.Yakimov - DWR UCIP)					
FIELD_STRUCT_DESC: *ABANDONED* 42-inch drainage pipe of an unknown material through the levee, 28.5 feet below the crown.					
Abandoned in place by plugging with concrete. Headwall on waterside (WS) toe. [Additional Reference(s): USACE Sacramento O&M Manual 130, May 1960 (HLM 0.22)].					
FS Date: 9/30/2019 9:45:45 AM

Ruins of a structure on LS

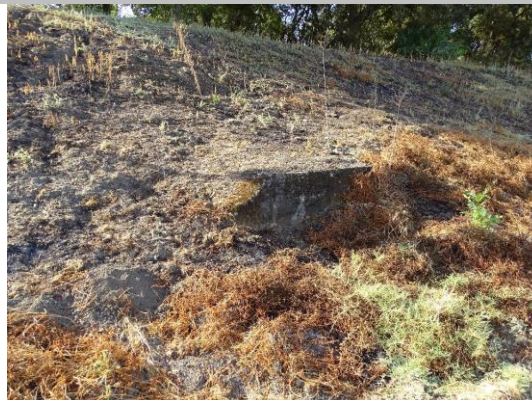
Photo 1 of 1 : UCIP_FA_2019_55795_82925.jpg

LM Start	0.23	Rating **	M	Issue No.	1556	
LM End	0.23	Issue Type +	En	Location *		
Category	Supplemental			GPS Latitude/Longitude		
				Start	End	
Item	DRAFT DWR UCIP Field Study			38.802349°	38.802349°	
				-121.724590°	-121.724590°	
DWR ID	20328					
Comment Code						
Inspector Comment						
DS_ID:20328						
FS_ID:55795						
EP_NO: N/A						
Repair Type: Non-Urgent						
Crossing Status: Indicator Found						
UCIP Comments: 09/30/2019 Top of concrete headwall visible on LS slope. Crossing looks abandoned (O.Yakimov - DWR UCIP)						
FIELD_STRUCT_DESC: *ABANDONED* 6-inch pipe of an unknown type and material through the levee, 10.3 feet below the crown. Abandoned by plugging with concrete. [Additional Reference(s): USACE Sacramento O&M Manual 130, May 1960 (HLM 0.23)].						
FS Date: 9/30/2019

Concrete headwall on LS slope

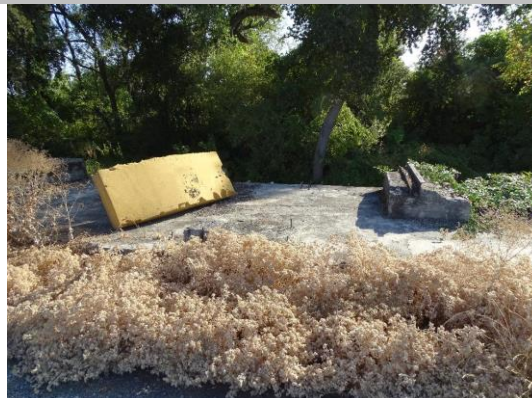
Photo 1 of 3 : UCIP_FA_2019_55797_82926.jpg

Comment Code					
Inspector Comment					
DS_ID:20225					
FS_ID:55797					
EP_NO: N/A					
Repair Type: Non-Urgent					
Crossing Status: Indicator Found					
UCIP Comments: 09/30/2019 Abandoned concrete bulkhead on WS shoulder visible. (O.Yakimov - DWR UCIP)					
FIELD_STRUCT_DESC: *ABANDONED* 1 of 3: 36-inch steel irrigation pipe through the levee, 18.3 feet below the crown. Steel plates bolted on the crown. Steel plates bolted on the waterside (WS) end. Pipes plugged with concrete. Concrete bulkhead on the WS slope. [Additional Reference(s): DWR Levee Log, 2006. USACE Sacramento O&M Manual 130, May 1960 (HLM 0.32)].					
FS Date: 9/30/2019 10:10:23 AM

View of WS looking from levee crown

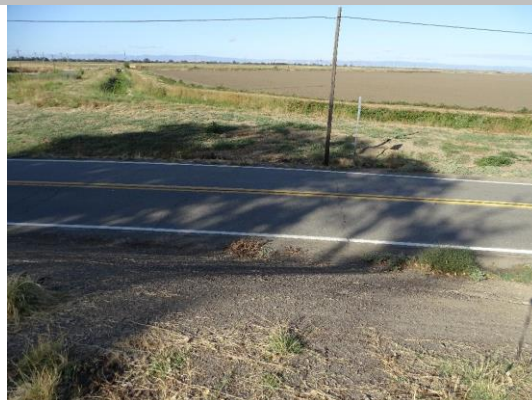
Photo 2 of 3 : UCIP_FA_2019_55797_82927.jpg

View of LS looking from levee crown

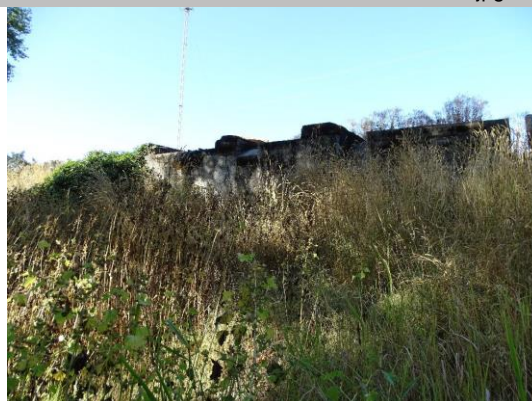
Photo 3 of 3 : UCIP_FA_2019_55797_82928.jpg

Comment Code						
Inspector Comment						
DS_ID:20225						
FS_ID:55797						
EP_NO: N/A						
Repair Type: Non-Urgent						
Crossing Status: Indicator Found						
UCIP Comments: 09/30/2019 Abandoned concrete bulkhead on WS shoulder visible. (O.Yakimov - DWR UCIP)						
FIELD_STRUCT_DESC: *ABANDONED* 1 of 3: 36-inch steel irrigation pipe through the levee, 18.3 feet below the crown. Steel plates bolted on the crown. Steel plates bolted on the waterside (WS) end. Pipes plugged with concrete. Concrete bulkhead on the WS slope. [Additional Reference(s): DWR Levee Log, 2006. USACE Sacramento O&M Manual 130, May 1960 (HLM 0.32)].						
FS Date: 9/30/2019 10:10:23 AM

Concrete bulkhead on the WS slope

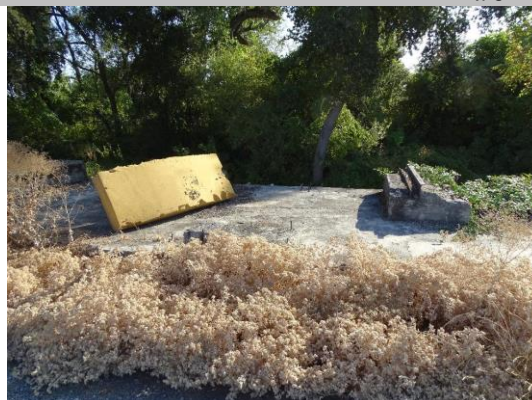
Photo 1 of 3 : UCIP_FA_2019_55798_82929.jpg

Comment Code					
Inspector Comment					
DS_ID:20358					
FS_ID:55798					
EP_NO: N/A					
Repair Type: Non-Urgent					
Crossing Status: Indicator Found					
UCIP Comments: 09/30/2019 Abandoned concrete bulkhead on WS shoulder visible. (O.Yakimov - DWR UCIP)					
FIELD_STRUCT_DESC: *ABANDONED* 2 of 3: 36-inch steel irrigation pipe through the levee, 18.3 feet below the crown. Steel plates bolted on the crown. Steel plates bolted on the waterside (WS) end. Pipes plugged with concrete. Concrete bulkhead on the WS slope. [Additional Reference(s): DWR Levee Log, 2006. USACE Sacramento O&M Manual 130, May 1960 (HLM 0.32)].					
FS Date: 9/30/2019

View of WS looking from levee crown

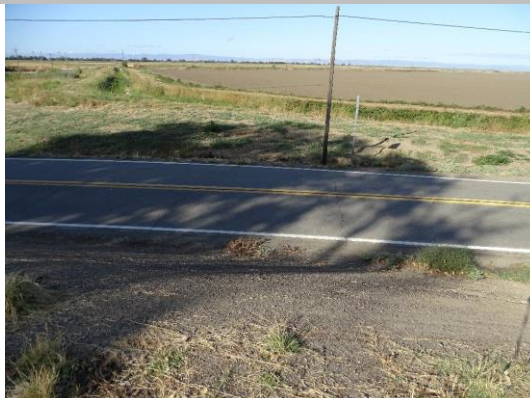
Photo 2 of 3 : UCIP_FA_2019_55798_82930.jpg

Comment Code						
Inspector Comment						
DS_ID:20358						
FS_ID:55798						
EP_NO: N/A						
Repair Type: Non-Urgent						
Crossing Status: Indicator Found						
UCIP Comments: 09/30/2019 Abandoned concrete bulkhead on WS shoulder visible. (O.Yakimov - DWR UCIP)						
FIELD_STRUCT_DESC: *ABANDONED* 2 of 3: 36-inch steel irrigation pipe through the levee, 18.3 feet below the crown. Steel plates bolted on the crown. Steel plates bolted on the waterside (WS) end. Pipes plugged with concrete. Concrete bulkhead on the WS slope. [Additional Reference(s): DWR Levee Log, 2006. USACE Sacramento O&M Manual 130, May 1960 (HLM 0.32)].						
FS Date: 9/30/2019

View of LS looking from levee crown

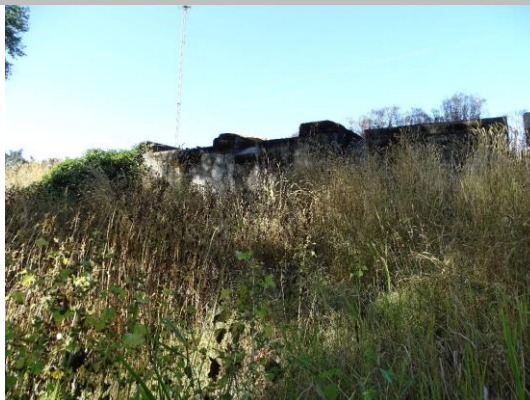
Photo 3 of 3 : UCIP_FA_2019_55798_82931.jpg

Concrete bulkhead on the WS slope

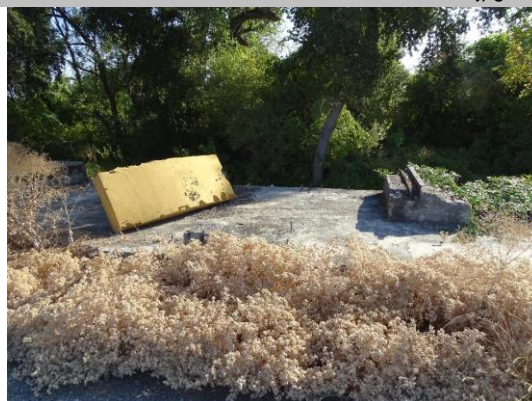
Photo 1 of 3 : UCIP_FA_2019_55799_82932.jpg

Comment Code						
Inspector Comment						
DS_ID:20359						
FS_ID:55799						
EP_NO: N/A						
Repair Type: Non-Urgent						
Crossing Status: Indicator Found						
UCIP Comments: 09/30/2019 Abandoned concrete bulkhead on WS shoulder visible. (O.Yakimov - DWR UCIP)						
FIELD_STRUCT_DESC: *ABANDONED* 3 of 3: 36-inch steel irrigation pipe through the levee, 18.3 feet below the crown. Steel plates bolted on the crown. Steel plates bolted on the waterside (WS) end. Pipes plugged with concrete. Concrete bulkhead on the WS slope. [Additional Reference(s): DWR Levee Log, 2006. USACE Sacramento O&M Manual 130, May 1960 (HLM 0.32)].						
FS Date: 9/30/2019 10:17:27 AM

View of WS looking from levee crown

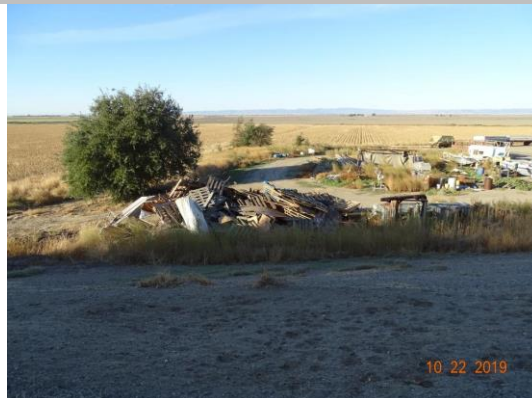
Photo 1 of 3 : FA_2019_NA0016_435_1550_20191023_00281.jpg

LM Start	2.40	Rating **	M	Issue No.	1550
LM End	2.40	Issue Type +	En	Location *	LS
Category	Earthen Levee			GPS Latitude/Longitude	
				Start	End
Item	Encroachments			38.832295 °	38.832295 °
				-121.729408 °	-121.729408 °
DWR ID	DWR_NA0016_01_f_2013_1550				
Comment Code					
EQ : Equipment					
Inspector Comment					
Equipment is located at the levee toe.

View of equipment and debris at the landside toe. Fall 2019.

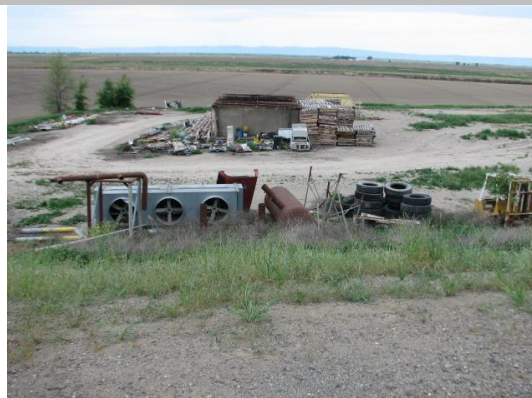
Photo 2 of 3 : FA_2019_NA0016_435_1550_20190829_00068.jpg

Pieces of machinery and debris at the levee toe. Spring 2014

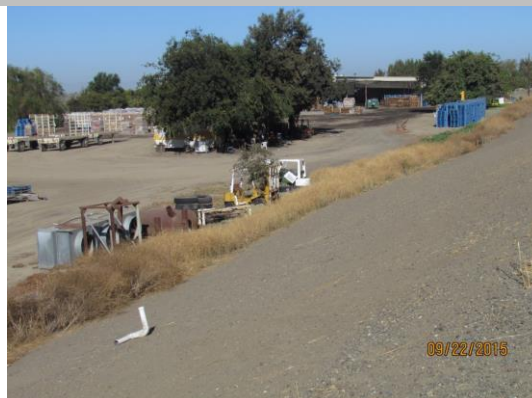
Photo 3 of 3 : FA_2019_NA0016_435_1550_20190829_00069.jpg

View of the machinery along the landward levee toe looking upstream.
Fall 2015.

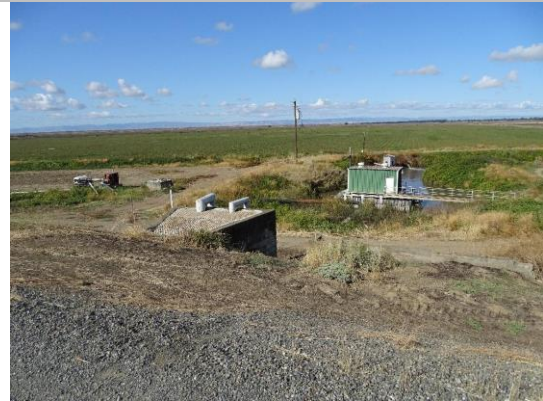
Photo 1 of 3 : UCIP_FA_2019_55802_82942.jpg

View of LS looking from levee crown

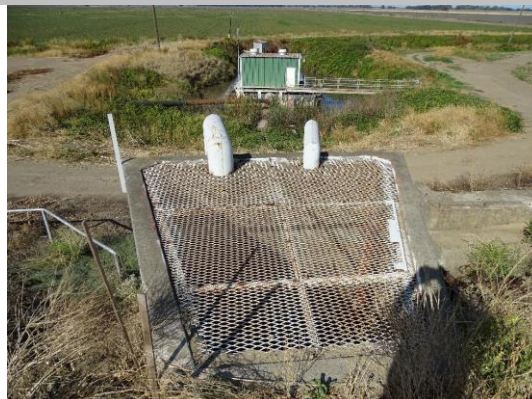
Photo 2 of 2 : UCIP_FA_2019_55804_82947.jpg

Comment Code						
Inspector Comment						
DS_ID:20227 FS_ID:55804 EP_NO: 1684 Repair Type: Non-Urgent Crossing Status: Indicator Found UCIP Comments: 09/30/2019 Unable to find an indicator of pipe. Concrete distribution box is covered with metal grating sheet not letting look down inside the box. (O.Yakimov - DWR UCIP) FIELD_STRUCT_DESC: 44-inch steel storm drainage pipe through the levee, 25 feet below the crown. Slide gate on both ends. Siphon breaker on the waterside (WS). Two concrete cutoff walls. Metal walkway to slide gate on the WS. (Permit No. 1684, 1952 - River Farms Company of California). Pipe discharges into 5-foot by 5-foot concrete tunnel. [Additional Reference(s): DWR Levee Log, 2006. USACE Sacramento O&M Manual 130, May 1960, (HLM 3.59), listed as a 42-inch pipe, 14.5 feet below the crown]. FS Date: 9/30/2019

44-inch pipe discharges into 5' x 5' concrete tunnel at the bottom of this box

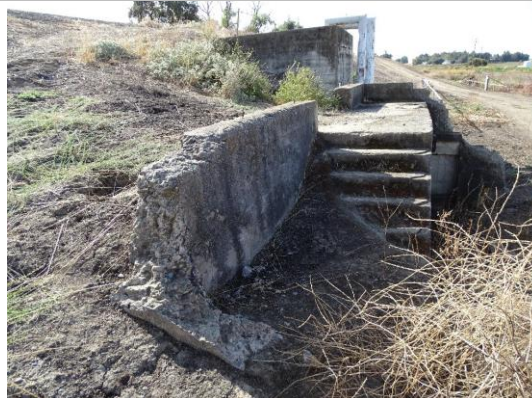
Photo 1 of 3 : UCIP_FA_2019_55806_82949.jpg

Comment Code						
Inspector Comment						
DS_ID:20330						
FS_ID:55806						
EP_NO: N/A						
Repair Type: Non-Urgent						
Crossing Status: Indicator Found						
UCIP Comments: 09/30/2019 Pipe not found on waterside. As observed on LS, 42-inch pipe plugged with soil, concrete, and pieces of CMP. Need to do proper abandonment of the pipe. (O.Yakimov - DWR UCIP)						
FIELD_STRUCT_DESC: 42-inch drainage pipe of an unknown material through the levee, 14.5 feet below the crown. Bolted steel plate on one end. Concrete pump platform on the landside (LS). Concrete pipe support/headwall visible inside short tunnel on the LS slope. [Additional Reference(s): USACE Sacramento O&M Manual 130, May 1960 (HLM 3.59)].						
FS Date: 9/30/2019 1:37:24 PM

Disrupted structure at LS toe with stairs on the top of channel

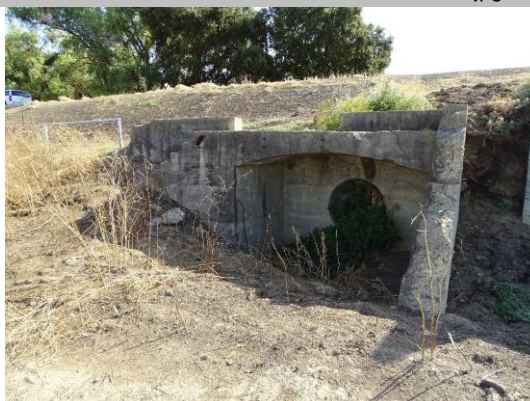
Photo 2 of 3 : UCIP_FA_2019_55806_82950.jpg

Comment Code						
Inspector Comment						
DS_ID:20330 FS_ID:55806 EP_NO: N/A Repair Type: Non-Urgent Crossing Status: Indicator Found UCIP Comments: 09/30/2019 Pipe not found on waterside. As observed on LS, 42-inch pipe plugged with soil, concrete, and pieces of CMP. Need to do proper abandonment of the pipe. (O.Yakimov - DWR UCIP) FIELD_STRUCT_DESC: 42-inch drainage pipe of an unknown material through the levee, 14.5 feet below the crown. Bolted steel plate on one end. Concrete pump platform on the landside (LS). Concrete pipe support/headwall visible inside short tunnel on the LS slope. [Additional Reference(s): USACE Sacramento O&M Manual 130, May 1960 (HLM 3.59)]. FS Date: 9/30/2019 1:37:24 PM

Disrupted structure with a channel where headwall and pipe observed

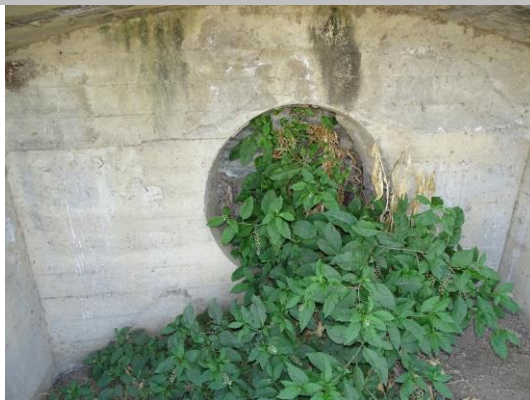
Photo 3 of 3 : UCIP_FA_2019_55806_82948.jpg

Pipe and headwall on LS

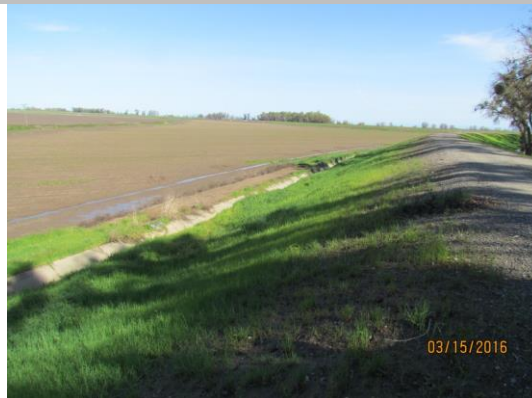
Photo 1 of 1 : FA_2019_NA0016_435_8_20190829_00001.jpg

LM Start	3.56	Rating **	M	Issue No.	8
LM End	3.94	Issue Type +	En	Location *	LS
Category	Earthen Levee			GPS Latitude/Longitude	
				Start	End
Item	Encroachments			38.846785 °	38.850758 °
				-121.729995 °	-121.725263 °
DWR ID	DWR_NA0016_01_s_2012_8				
Comment Code					
DT : Ditch					
Inspector Comment					
Concrete lined ditch runs along the levee toe.

View of the ditch on the landward side of the levee looking upstream. Spring 2016.

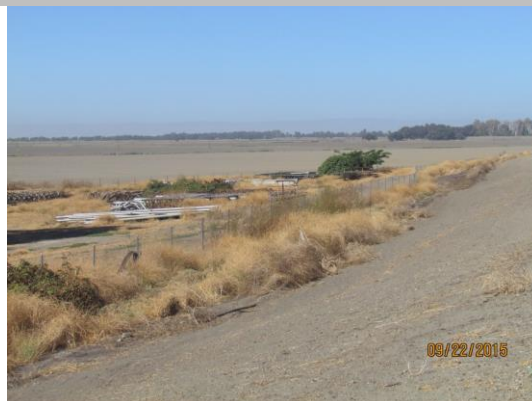
Photo 1 of 1 : FA_2019_NA0016_435_9_20190829_00002.jpg

LM Start	4.80	Rating **	M	Issue No.	9
LM End	4.80	Issue Type +	En	Location *	LS
Category	Earthen Levee			GPS Latitude/Longitude	
				Start	End
Item	Encroachments			38.859446 °	38.859446 °
				-121.732774 °	-121.732774 °
DWR ID	DWR_NA0016_01_s_2012_9				
Comment Code					
FE : Fence					
Inspector Comment					
A chain link fence runs along levee toe.

View of the chain link fence along the landward levee toe looking upstream. The fence does not obstruct the view. Fall 2015.

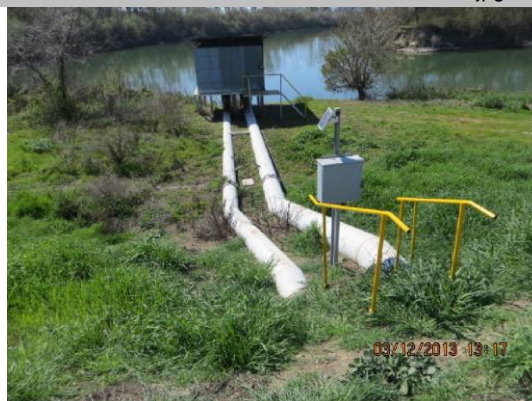
Photo 2 of 3 : UCIP_FA_2019_10129_17290.jpg

Comment Code						
Inspector Comment						
DS_ID:20228 FS_ID:10129 EP_NO: 1297 Repair Type: Non-Urgent Crossing Status: Not Found UCIP Comments: See DSID 25126 of replacement pipe Leak at flowmeter on WS berm may become problem in near future. FIELD_STRUCT_DESC: *REMOVED* 2 of 2: 16-inch steel irrigation pipe through the levee, 5.2 feet below the crown. Slant pumps in a metal pump house on the waterside (WS) bank, supported on a steel structure. Pipes discharge into a 9.5-foot by 12-foot concrete distribution box on the landside (LS). Sparline flow meter on pipes near the WS toe. (Permit No. 1297, 1948 - River Farms Company of California; removed under Permit No. 8501, 2012 - River Garden Farms, Inc.). [Additional Reference(s): DWR Levee Log, 2006. USACE Sacramento O&M Manual 130, May 1960 (HLM 6.89) listed as a 14-inch pipe]. FS Date: 3/12/2013

Pumphouse and steps on WS.

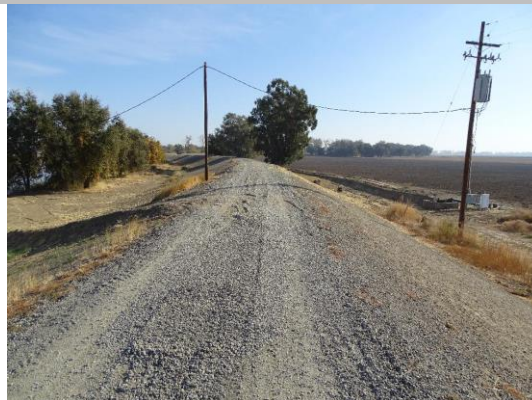
Photo 1 of 3 : UCIP_FA_2019_55828_83047.jpg

Comment Code					
Inspector Comment					
DS_ID:20428 FS_ID:55828 EP_NO: 18206 Repair Type: Non-Urgent Crossing Status: Found UCIP Comments: 11/07/2019 Unable to find permit for structure modification. Modification includes: Timber walkway to pump house removed, CMP riser with siphon breaker on LS shoulder removed, poer pole next to CB on LS installed, flap gate in CB on LS removed, CMP raiser with bolted flange plate at pump house installed. (O.Yakimov - DWR UCIP)03/13/2013 Flap gates rusted through at concrete distribution box on LS toe. FIELD_STRUCT_DESC: 1 of 2: 20-inch steel irrigation pipe through the levee, 4.7 feet below the crown. Slant pump inside pump house on the waterside (WS) berm. Siphon breaker inside corrugated metal riser unit on the shoulder. Flap gate on pipe inside concrete distribution box on the landside (LS). Wooden steps on both slopes. (Permit No. 18206, 2007 - River Garden Farms). (Replaced 20-inch pipe installed under Permit No. 9377, 1974 - Faye Properties, Inc.). [Additional Reference(s): DWR Levee Log, 2006]. FS Date: 11/7/2019 9:44:04 AM

View of levee crown at the crossing

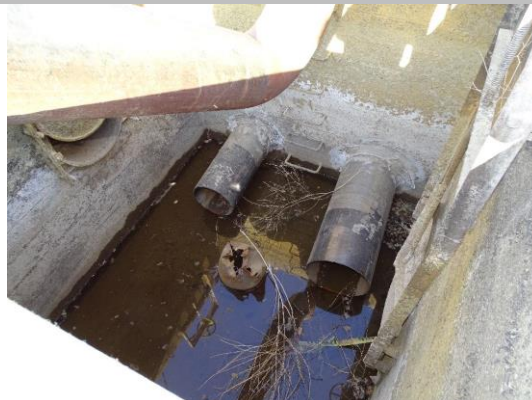
Photo 2 of 3 : UCIP_FA_2019_55828_83048.jpg

View inside of concrete distribution box on LS

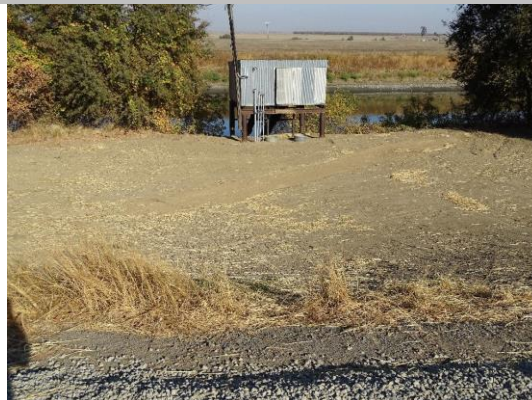
Photo 1 of 3 : UCIP_FA_2019_55831_83059.jpg

DS_ID:20427
 FS_ID:55831
 EP_NO: 18206
 Repair Type: Non-Urgent
 Crossing Status: Found
 UCIP Comments: 11/07/2019 Unable to find permit for structure modification. Modification includes: Timber walkway to pump house removed, CMP riser with siphon breaker on LS shoulder removed, poer pole next to CB on LS installed, flap gate in CB on LS removed, CMP raiser with bolted flange plate at pump house installed. (O.Yakimov - DWR UCIP03/13/2013 Flap gates rusted through at LS distribution box.
 FIELD_STRUCT_DESC: 2 of 2: 16-inch steel irrigation pipe through the levee, 4.7 feet below the crown. Slant pump inside pump house on the waterside (WS) berm. Siphon breaker inside corrugated metal riser unit on the shoulder. Flap gate on pipe inside concrete distribution box on the landside (LS). Wooden steps on both slopes. (Permit No. 18206, 2007 - River Garden Farms). (Replaced 16-inch pipe installed under Permit No. 9377, 1974 - Faye Properties, Inc.). [Additional Reference(s): DWR Levee Log, 2006].

View of WS looking from levee crown

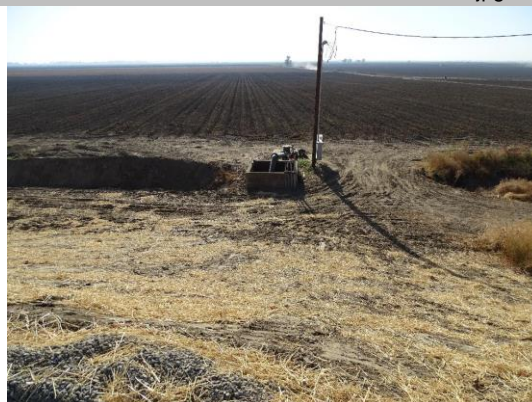
Photo 2 of 3 : UCIP_FA_2019_55831_83058.jpg

View of LS looking from levee crown

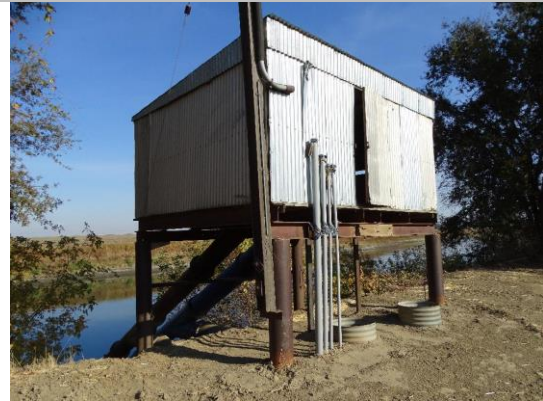
Photo 3 of 3 : UCIP_FA_2019_55831_83060.jpg

Pump house on WS

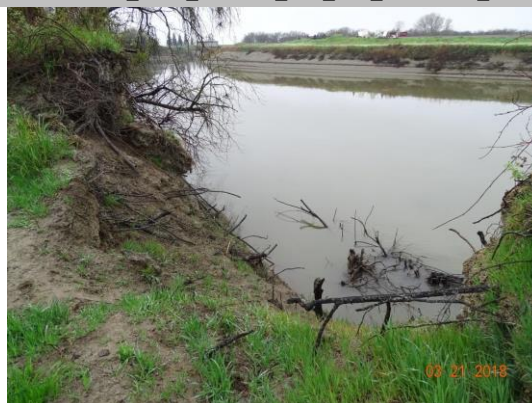
Photo 3 of 4 : FA_2019_NA0016_435_112_20190829_00045.jpg

LM Start	8.55	Rating **	A/W	Issue No.	112 (cont)	
LM End	8.55	Issue Type +	Ma	Location *	WS	
Category	Earthen Levee			GPS Latitude/Longitude		
				Start	End	
Item	Erosion / Bank Caving			38.857422 °	38.857422 °	
				-121.780870 °	-121.780870 °	
DWR ID	DWR_NA0016_01_s_2018_112					
Comment Code						
E1 : Note and monitor erosion site.						
Inspector Comment						
Location on waterside berm where oak tree fell and removed soil around the roots. Appears to be stable, but recommend monitoring.

View of the remaining roots, facing upstream. Spring 2018.

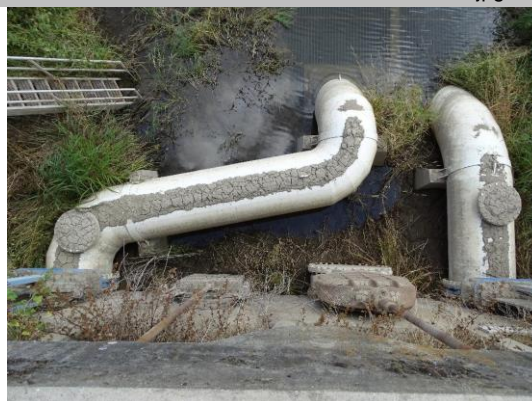
Photo 1 of 3 : UCIP_FA_2019_55837_83095.jpg

Comment Code						
Inspector Comment						
DS_ID:20230 FS_ID:55837 EP_NO: 9376 Repair Type: Non-Urgent Crossing Status: Found UCIP Comments: 09/30/2019 No issues recorded during inspection (O.Yakimov - DWR UCIP) FIELD_STRUCT_DESC: [El Dorado Bend Pumping Plant] 1 of 4: 50-inch sleeved through existing 54-inch concrete encased steel drainage pipe through the levee, 26.5 feet below the crown. Gate valves on the waterside (WS) ends of the pipes. Walkway provided to the control valves and around the pump house on the landside (LS). Pipes originate in a large concrete pool at the pump house on the LS. (54-inch pipe [HLM 5.27] authorized under Automatic Board Order (ABO) issued as Permit No. 9376, 1974 - Reclamation District Nos. 2047 and 108; 50-inch pipe sleeved through existing 54-inch pipe and trash rack repairs authorized under maintenance in 2013). [Additional Reference(s): DWR Levee Log, 2006. USACE Sacramento O&M Manual 130, May 1960 (HLM 8.99)]. FS Date: 9/30/2019 11:08:36 AM

Headwall, slide gate, pipe in river channel

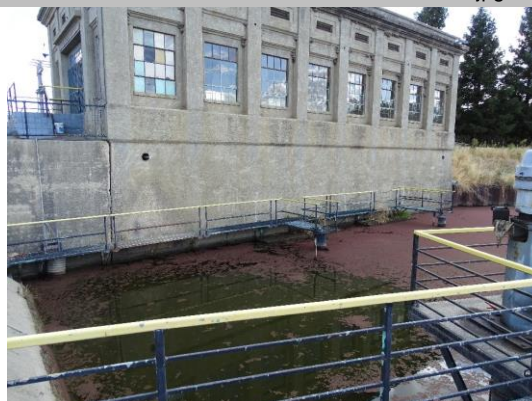
Photo 3 of 3 : UCIP_FA_2019_55837_83096.jpg

LS view of pumping plant looking from irrigation canal

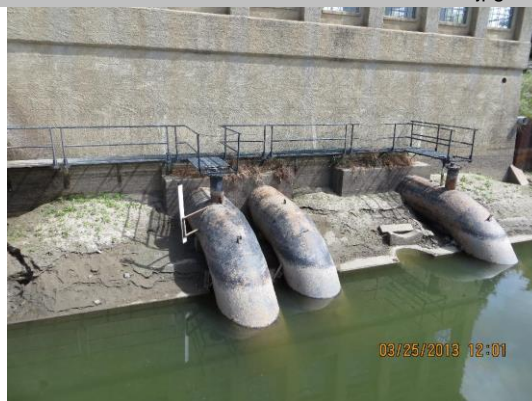
Photo 3 of 3 : UCIP_FA_2019_55838_17317.jpg

Pipe missing from intake structure on LS of pumphouse.

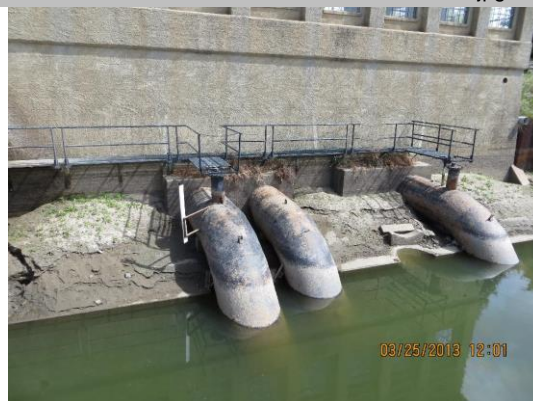
Photo 3 of 3 : UCIP_FA_2019_55839_17321.jpg

Pipes at inlet on LS of pumphouse.

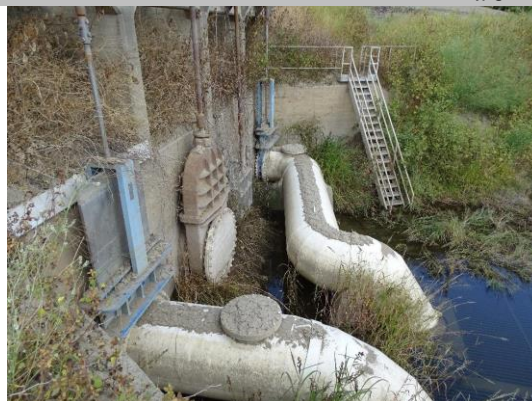
Photo 2 of 3 : UCIP_FA_2019_55836_83073.jpg

Comment Code						
Inspector Comment						
DS_ID:20363 FS_ID:55836 EP_NO: 9376 Repair Type: Non-Urgent Crossing Status: Found UCIP Comments: 09/30/2019 Pipe outlet on WS has been modified to serve at inlet. Pipe runs down to a sump in river channel. (O.Yakimov - DWR UCIP) FIELD_STRUCT_DESC: [El Dorado Bend Pumping Plant] 4 of 4: 50-inch sleeved through existing 54-inch concrete encased steel drainage discharge pipe through the levee, 26.5 feet below the crown. Gate valves on both ends of the pipe. Walkway provided to the control valves. (54-inch pipe [HLM 5.27] authorized under Automatic Board Order (ABO) issued as Permit No. 9376, 1974 - Reclamation District Nos. 2047 and 108; 50-inch pipe sleeved through existing 54-inch pipe and trash rack repairs authorized under maintenance in 2013). [Additional Reference(s): DWR Levee Log, 2006. USACE Sacramento O&M Manual 130, May 1960 (HLM 8.99)]. FS Date: 9/30/2019 10:56:50 AM

Headwall, slide gate, pipe in river channel

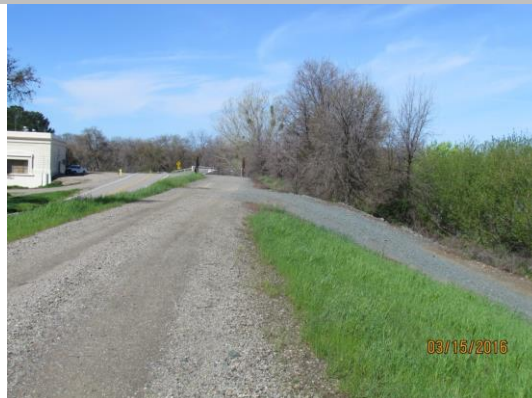
Photo 1 of 2 : FA_2019_NA0016_435_29_20190829_00007.jpg

LM Start	9.68	Rating **	A/W	Issue No.	29
LM End	9.79	Issue Type +	Ma	Location *	WS
Category	Earthen Levee			GPS Latitude/Longitude	
				Start	End
Item	Vegetation			38.862345°	38.862848°
				-121.791337°	-121.793267°
DWR ID	DWR_NA0016_01_s_2012_29				
Comment Code					
V8 : Environmental Requirements.					
Inspector Comment

View of the revegetation site on the waterward side of the levee looking upstream. Spring 2016.

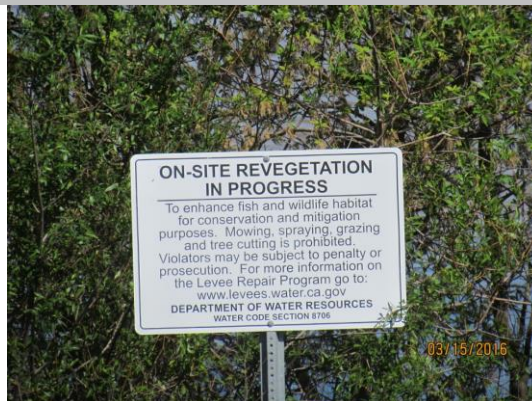
Photo 2 of 2 : FA_2019_NA0016_435_29_20190829_00008.jpg

Revegetation site sign. Spring 2016.

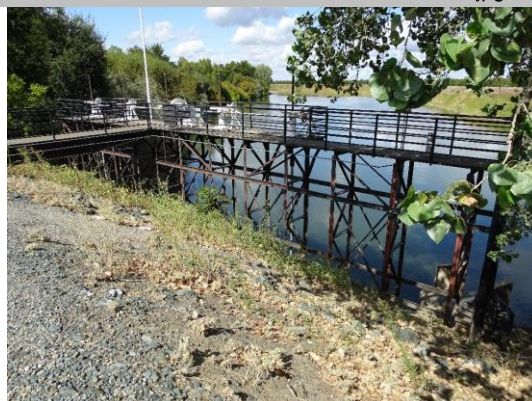
Photo 1 of 3 : UCIP_FA_2019_55842_83088.jpg

LM Start	9.75	Rating **	M	Issue No.	1574	
LM End	9.75	Issue Type +	Ma	Location *		
Category	Supplemental			GPS Latitude/Longitude		
				Start	End	
Item	DRAFT DWR UCIP LMA Responsibility			38.862615 °	38.862615 °	
				-121.792582 °	-121.792582 °	
DWR ID	20232					
Comment Code						
Inspector Comment						
DS_ID:20232 FS_ID:55842 EP_NO: N/A Repair Type: Non-Urgent Crossing Status: Found UCIP Comments: 09/30/2019 No issues recorded during inspection (O.Yakimov - DWR UCIP) FIELD_STRUCT_DESC: 1 of 5: 60-inch reinforced concrete drainage culvert through the levee, 35 feet below the crown. Screw gates on walkway at waterside (WS) shoulder. Staff gauge to 47.0 feet on structure. [Additional Reference(s): DWR Levee Log, 2006. USACE Sacramento O&M Manual 130, May 1960 (HLM 9.87)]. FS Date: 9/30/2019 11:47:04 AM

Slide gate actuators on WS shoulder

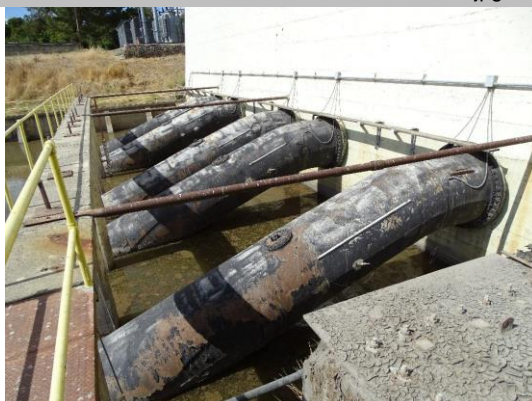
Photo 3 of 3 : UCIP_FA_2019_55842_83098.jpg

Pipes at entrance to pumping plant building on LS toe

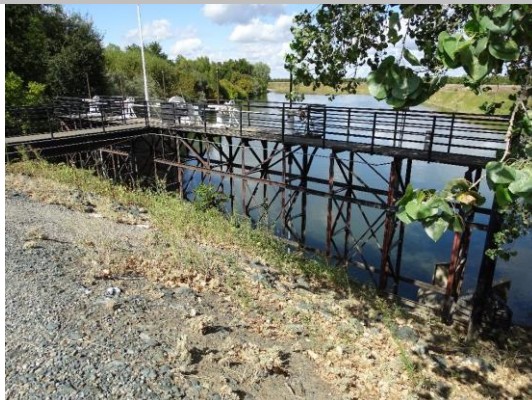
Photo 1 of 3 : UCIP_FA_2019_55843_83099.jpg

Comment Code					
Inspector Comment					
DS_ID:20364					
FS_ID:55843					
EP_NO: N/A					
Repair Type: Non-Urgent					
Crossing Status: Found					
UCIP Comments: 09/30/2019 No issues recorded during inspection (O.Yakimov - DWR UCIP)					
FIELD_STRUCT_DESC: 2 of 5: 60-inch reinforced concrete drainage culvert through the levee, 35 feet below the crown. Screw gate actuators on metal platform on the waterside (WS) shoulder. Large pumping plant building on the landside (LS) shoulder. Staff gauge to 47 feet on structure. [Additional Reference(s): DWR Levee Log, 2006. USACE Sacramento O&M Manual 130, May 1960 (HLM 9.87)].					
FS Date: 9/30/2019 11:47:39 AM

Slide gate actuators on WS shoulder

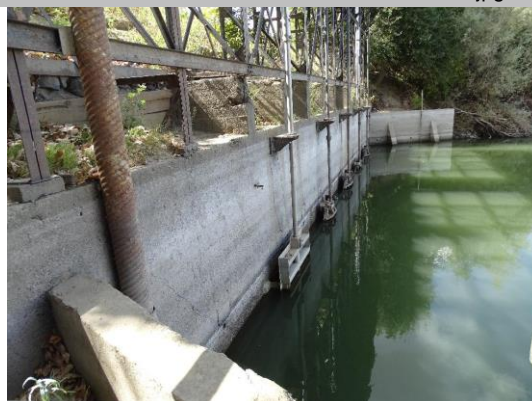
Photo 2 of 3 : UCIP_FA_2019_55843_83100.jpg

Comment Code						
Inspector Comment						
DS_ID:20364 FS_ID:55843 EP_NO: N/A Repair Type: Non-Urgent Crossing Status: Found UCIP Comments: 09/30/2019 No issues recorded during inspection (O.Yakimov - DWR UCIP) FIELD_STRUCT_DESC: 2 of 5: 60-inch reinforced concrete drainage culvert through the levee, 35 feet below the crown. Screw gate actuators on metal platform on the waterside (WS) shoulder. Large pumping plant building on the landside (LS) shoulder. Staff gauge to 47 feet on structure. [Additional Reference(s): DWR Levee Log, 2006. USACE Sacramento O&M Manual 130, May 1960 (HLM 9.87)]. FS Date: 9/30/2019 11:47:39 AM

Slide gates at concrete headwall at river

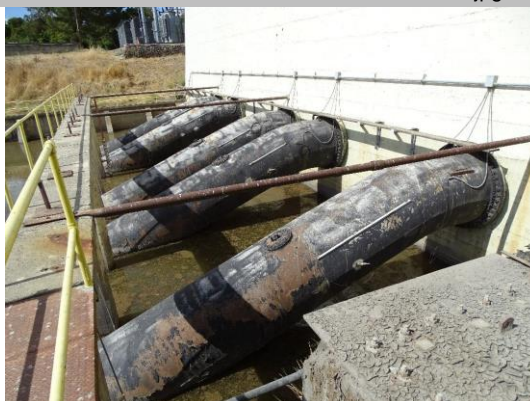
Photo 3 of 3 : UCIP_FA_2019_55844_83104.jpg

Comment Code						
Inspector Comment						
DS_ID:20365						
FS_ID:55844						
EP_NO: N/A						
Repair Type: Non-Urgent						
Crossing Status: Found						
UCIP Comments: 09/30/2019 No issues recorded during inspection (O.Yakimov - DWR UCIP)						
FIELD_STRUCT_DESC: 3 of 5: 60-inch reinforced concrete drainage culvert through the levee, 35 feet below the crown. Screw gate actuators on metal platform on the waterside (WS) shoulder. Large pumping plant building on the landside (LS) shoulder. Staff gauge to 47 feet on structure. [Additional Reference(s): DWR Levee Log, 2006. USACE Sacramento O&M Manual 130, May 1960 (HLM 9.87)].						
FS Date: 9/30/2019 11:48:05 AM

Pipes at entrance to pumping plant building on LS toe

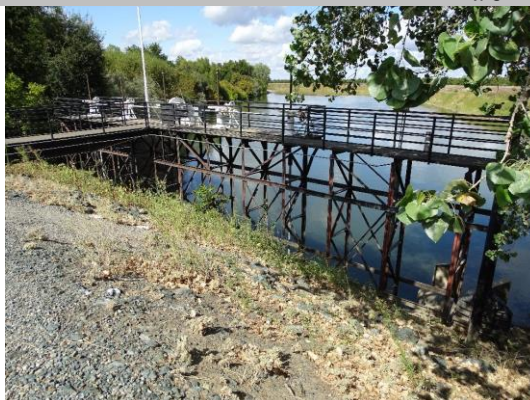
Photo 1 of 3 : UCIP_FA_2019_55845_83105.jpg

Comment Code						
Inspector Comment						
DS_ID:20366						
FS_ID:55845						
EP_NO: N/A						
Repair Type: Non-Urgent						
Crossing Status: Found						
UCIP Comments: 09/30/2019 No issues recorded during inspection (O.Yakimov - DWR UCIP)						
FIELD_STRUCT_DESC: 4 of 5: 60-inch reinforced concrete drainage culvert through the levee, 35 feet below the crown. Screw gate actuators on metal platform on the waterside (WS) shoulder. Large pumping plant building on the landside (LS) shoulder. Staff gauge to 47 feet on structure. [Additional Reference(s): DWR Levee Log, 2006. USACE Sacramento O&M Manual 130, May 1960 (HLM 9.87)].						
FS Date: 9/30/2019 11:48:29 AM

Slide gate actuators on WS shoulder

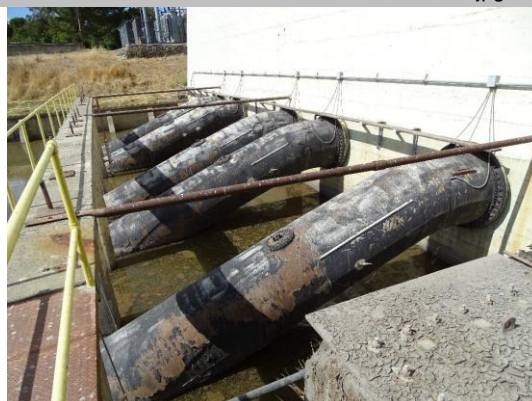
Photo 3 of 3 : UCIP_FA_2019_55846_83110.jpg

Comment Code						
Inspector Comment						
DS_ID:20367						
FS_ID:55846						
EP_NO: N/A						
Repair Type: Non-Urgent						
Crossing Status: Found						
UCIP Comments: 09/30/2019 No issues recorded during inspection (O.Yakimov - DWR UCIP)						
FIELD_STRUCT_DESC: 5 of 5: 60-inch reinforced concrete drainage culvert through the levee, 35 feet below the crown. Screw gate actuators on metal platform on the waterside (WS) shoulder. Large pumping plant building on the landside (LS) shoulder. Staff gauge to 47 feet on structure. [Additional Reference(s): DWR Levee Log, 2006. USACE Sacramento O&M Manual 130, May 1960 (HLM 9.87)].						
FS Date: 9/30/2019 11:48:54 AM

Pipes at entrance to pumping plant building on LS toe

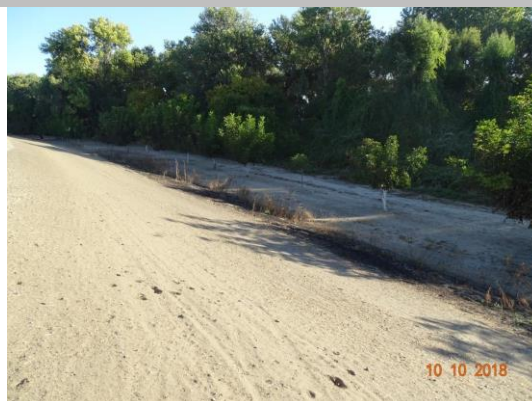
Photo 1 of 1 : FA_2019_NA0016_435_106_20190829_00040.jpg

LM Start	10.66	Rating **	M	Issue No.	106
LM End	10.80	Issue Type +	En	Location *	WS
Category	Earthen Levee			GPS Latitude/Longitude	
				Start	End
Item	Encroachments			38.866474 °	38.868426 °
				-121.803711 °	-121.803732 °
DWR ID	DWR_NA0016_01_f_2019_106				
Comment Code					
CR : Crops					
Inspector Comment					
A walnut orchard is located on the waterside berm.

View of walnut orchard on the waterside berm. Fall 2018.

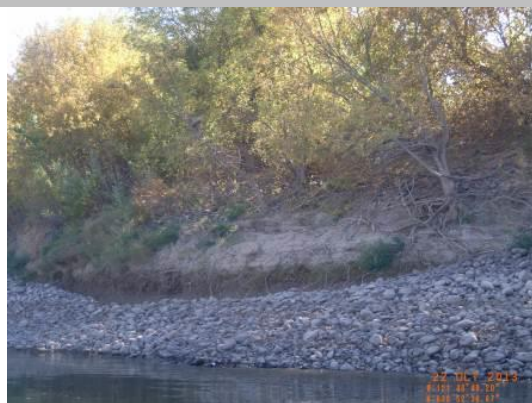
Photo 1 of 1 : FA_2019_NA0016_435_84_20190829_00022.jpg

LM Start	11.50	Rating **	A/W	Issue No.	84
LM End	11.53	Issue Type +	Ma	Location *	WS
Category	Supplemental			GPS Latitude/Longitude	
				Start	End
Item	2017 USACE Erosion Survey			38.874854 °	38.875109 °
				-121.813018 °	-121.813592 °
DWR ID	DWR_NA0016_01_f_2018_84				
Comment Code					
Inspector Comment					
2017 Site ID: SAC 101.3 R					
Status: Eroding					
2017 Field Notes: No observed change..					
Site History: 1997 - Toe damage and loss of cobble revetment and small patch of local damage to the cobble revetment. 2000 - Cohesive vertical toe; revegetation site.

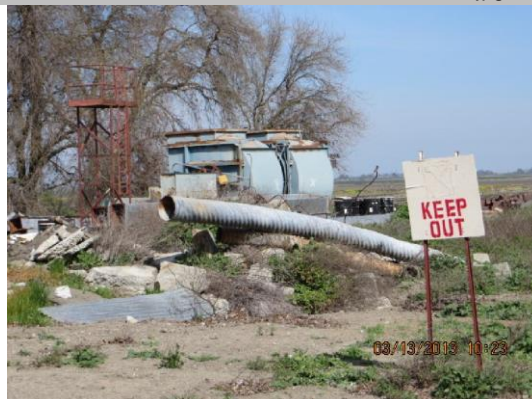
Photo 1 of 3 : UCIP_FA_2019_55856_17368.jpg

LM Start	12.28	Rating **	M	Issue No.	1579	
LM End	12.28	Issue Type +	En	Location *		
Category	Supplemental			GPS Latitude/Longitude		
				Start	End	
Item	DRAFT DWR UCIP Field Study			38.884428 °	38.884428 °	
				-121.817163 °	-121.817163 °	
DWR ID	20233					
Comment Code						
Inspector Comment						
DS_ID:20233						
FS_ID:55856						
EP_NO: N/A						
Repair Type: Non-Urgent						
Crossing Status: Not Found						
UCIP Comments: 09/30/2019 Crossing not found (O.Yakimov - DWR UCIP)						
FIELD_STRUCT_DESC: 9-inch corrugated metal drainage pipe through the levee, at an unknown depth. Installed prior to 1974. Pipe debris at LM 12.38 includes a 9-inch CMP. [Additional Reference(s): DWR Levee Log, 2006].						
FS Date: 9/30/2019 1:53:01 PM

Pipe debris on LS shoulder at LM 12.38 includes a 9-inch CMP.

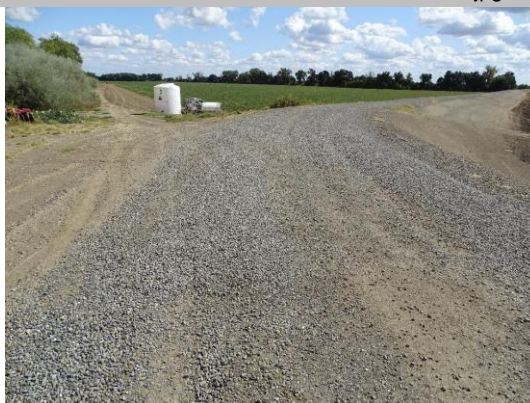
Photo 1 of 3 : UCIP_FA_2019_55858_83114.jpg

LM Start	14.09	Rating **	M	Issue No.	1580	
LM End	14.09	Issue Type +	En	Location *		
Category	Supplemental			GPS Latitude/Longitude		
				Start	End	
Item	DRAFT DWR UCIP Field Study			38.906235 °	38.906235 °	
				-121.807284 °	-121.807284 °	
DWR ID	20433					
Comment Code						
Inspector Comment						
DS_ID:20433						
FS_ID:55858						
EP_NO: N/A						
Repair Type: Non-Urgent						
Crossing Status: Found						
UCIP Comments: 09/30/2019 Permit is not available for this crossing.						
(O.Yakimov - DWR UCIP)						
FIELD_STRUCT_DESC: 1.5-inch galvanized steel electrical conduit						
through the levee, at an unknown depth. Provides service to pump on						
the waterside (WS).						
FS Date: 9/30/2019 1:59:39 PM

View of levee crown at the crossing

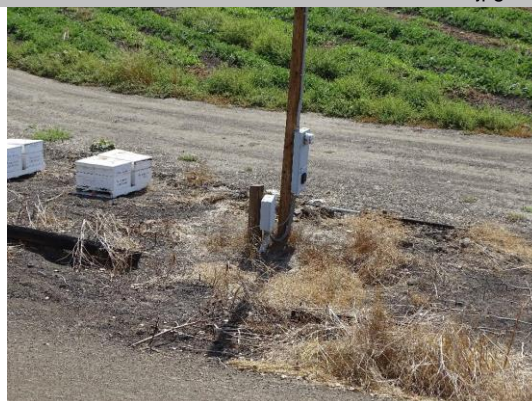
Photo 2 of 3 : UCIP_FA_2019_55858_83115.jpg

Service pole at LS toe

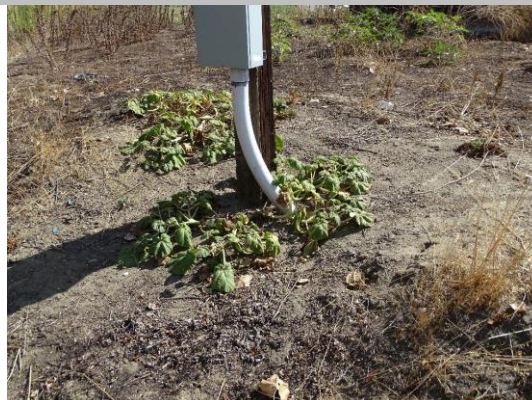
Photo 3 of 3 : UCIP_FA_2019_55858_83116.jpg

Conduit exits levee at WS toe

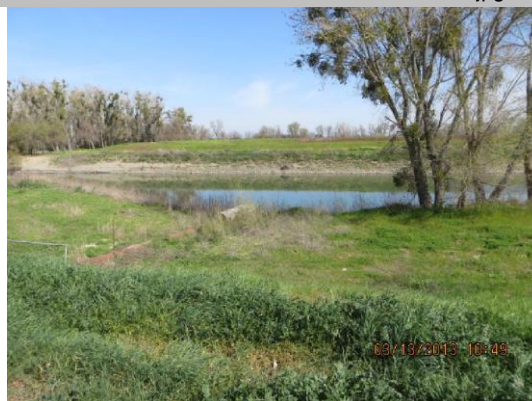
Photo 1 of 2 : UCIP_FA_2019_55860_27169.jpg

LM Start	14.36	Rating **	M	Issue No.	1581
LM End	14.36	Issue Type +	En	Location *	
Category	Supplemental			GPS Latitude/Longitude	
				Start	End
Item	DRAFT DWR UCIP Field Study			38.908034 °	38.908034 °
				-121.811747 °	-121.811747 °
DWR ID	20235				
Comment Code					
Inspector Comment					
DS_ID:20235 FS_ID:55860 EP_NO: 9354 Repair Type: Non-Urgent Crossing Status: Not Found UCIP Comments: 09/30/2019 Crossing not found (O.Yakimov - DWR UCIP) FIELD_STRUCT_DESC: *ABANDONED* 1 of 3: 36-inch steel irrigation pipe through the levee, 28 feet below the crown. Slide gates on the waterside (WS) ends. Grouted in place. No above-ground appurtenances remain. (Permit No. 9354, 1974 - Reclamation District No. 108). [Additional Reference(s): DWR Levee Log, 2006. USACE Sacramento O&M Manual 130, May 1960 (HLM 14.53)]. FS Date: 9/30/2019 2:47:36 PM

Pipe barrier along WS berm at approximate location of abandoned pumping plant.

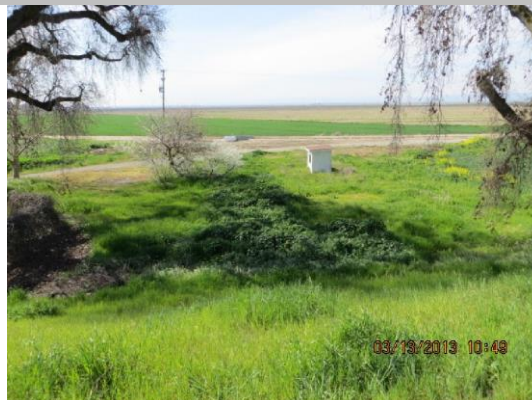
Photo 2 of 2 : UCIP_FA_2019_55860_27168.jpg

Site of abandoned pumping plant.
